## Earth-based mortars for masonry plastering

FARIA, PAULINA<sup>1</sup>; SANTOS, TÂNIA<sup>2</sup>; SILVA, VITOR<sup>3</sup>

**ABSTRACT:** Earth mortars have been applied since unknown times. Their advantages are ecological but also cover several technical aspects, in terms of compatibility with masonries, reversibility, comfort, aesthetic and health. Some requirements of a recent German standard, which focus on non-stabilized earth plastering mortars, are presented. A commercial premixed Portuguese earth mortar was made within an ECVET workshop and applied as plasters on four different experimental masonry walls, at exterior environmental conditions. The plasters were observed during six months and characterized *in situ* by non destructive techniques, namely by ultra-sounds and for surface hardness. The same mortar used for the plasters was characterized in laboratory in fresh state and samples of mortar (only mortar and mortar layer applied on brick) were produced and characterized after drying. The characterization of the earth plasters applied on the walls and of the mortar samples is presented and discussed, showing the viability of their use as plaster for different mason

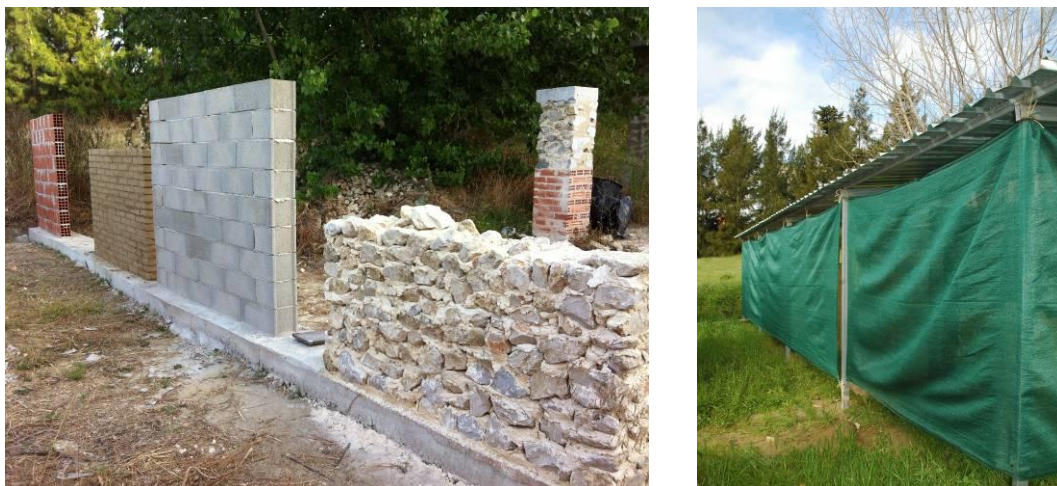
**Figure 1.** Four masonry test walls, yet unprotected – from the front to the back, rubble stone, concrete blocks, adobe and hollow bricks (left); protection of the experimental walls after plastered (right)

A simple concrete foundation was prepared and left to dry (Figure 2 – left). Four different masonry test walls were made over the foundation, without any damp proof layer: rubble stone with limestone and air lime mortar, concrete blocks with cement mortar, adobe blocks with earth mortar (the same earth used to produce the blocks) and hollow bricks with cement mortar. The test walls were made

one month before the application of the plaster, during summer time, and were left unprotected. The dimensions of the surfaces of the walls varied between 1.0-1.8 m height and 1.2-2.2 m length and the experimental walls can be seen in Figure 1 - left.

The earth mortar was not chemically stabilized with any mineral binder and, for that reason, could be affected by rainfall. The plastered masonry test walls were protected by a continuous top covering with 2.2m two months after being completed. Fortunately there was not much rainfall during that period. Nevertheless and even with the top covering, as the South wind is very strong at the Experimental Station, it could be observed that degradation occurred at the underside of the south facing plaster panels, due to insufficient protection from rainfall. For that reason, a protection net was afterwards vertically positioned on the lateral sides of the test walls' covering (Figure 1 - right).

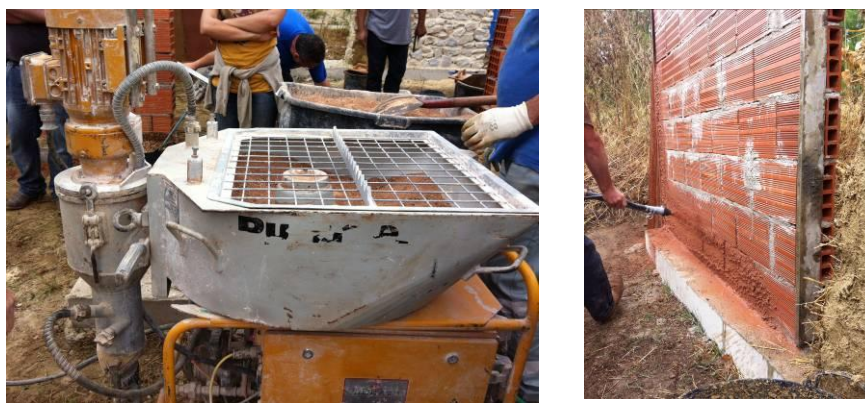
**Figure 2.** Mechanical mixing (left) and application (right) equipment

A commercial earth mortar, constituted by a clayish earth, sand with particle size distribution between 0-2mm and oat fibres with 1-2cm longer, was mechanically prepared with a quantity of water to allow an easy application, by a mechanical equipment (Figure 2 - left), and finishing (Figure 2 – right).

The mortar was directly applied on the four masonry test walls, after being sprayed with water (Figure 2 – right, for the brick wall). The plaster was easily levelled with a screed (Figure3, for the brick wall). The thickness of all the plasters was around 2cm.

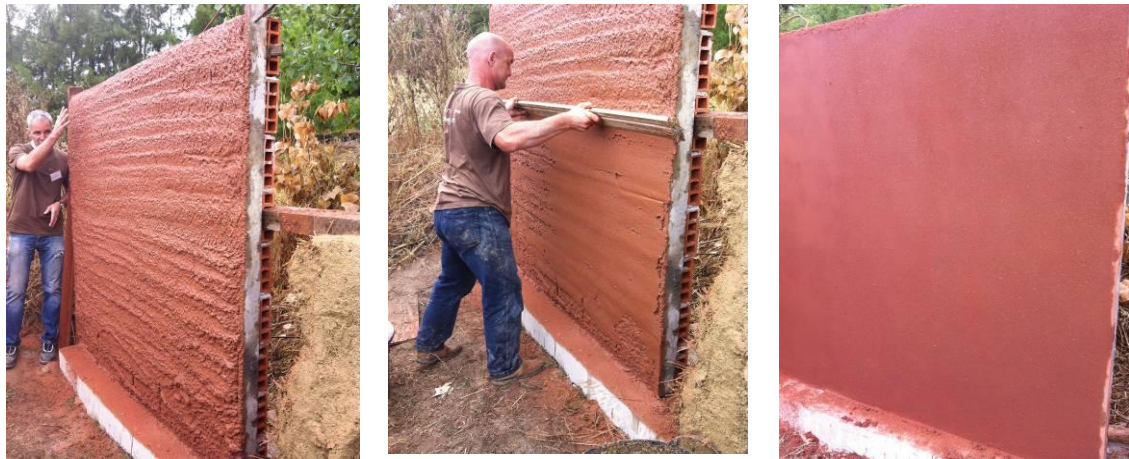
**Figure 3.** Commercial earth plaster on the hollow brick test wall after projection (left), being levelled (middle) and finished (right)

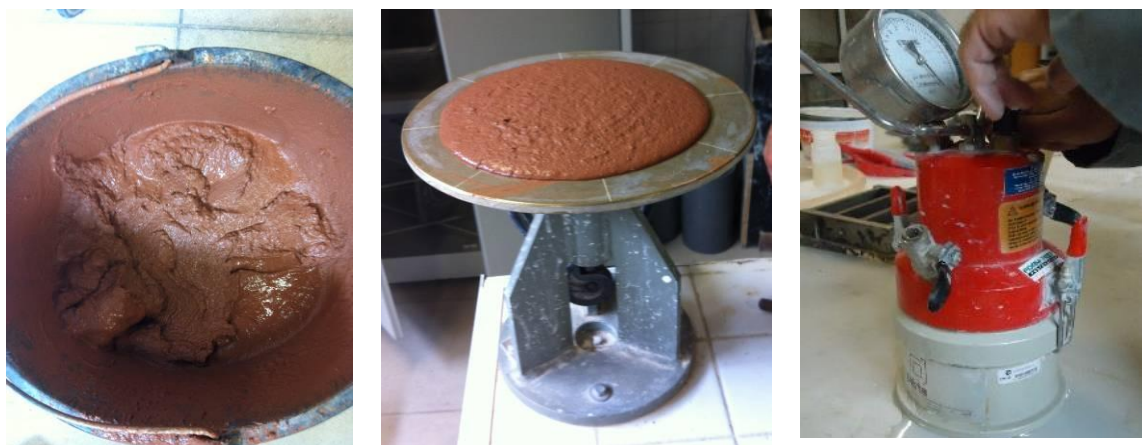
**Figure 4.** Fresh mortar (left), consistency flow table test (middle) and air content determination (right)

Alongside, the mortar was characterized in laboratory in the fresh state (Figure 4 – left), in terms of flow table consistency (Figure 4 - middle), bulk density, water content and air content (Figure 4 - right). Several mortar samples were produced with the same commercial earth mortar, from the same *in situ* batch. Prismatic 40x40x160 [mm] samples were mechanically compacted in two layers on metallic moulds and superficially levelled (Figure 5 – left). Circular samples, with 60mm diameter and 15mm thickness, were produced in plastic moulds and manually compacted (Figure 5 – middle). For the production of samples of mortar on hollow brick, the bricks were previously water sprayed, the mortar were left to fall from 70 cm height to simulate the *in situ* application energy and then superficially levelled, presenting a mortar thickness of 1.5cm (Figure 5 – right).

As said before, the mortar's workability was remarkably, both *in situ* and in laboratory. The flow table consistency was  $178.8 \pm 2.5$  mm (Figure 4).

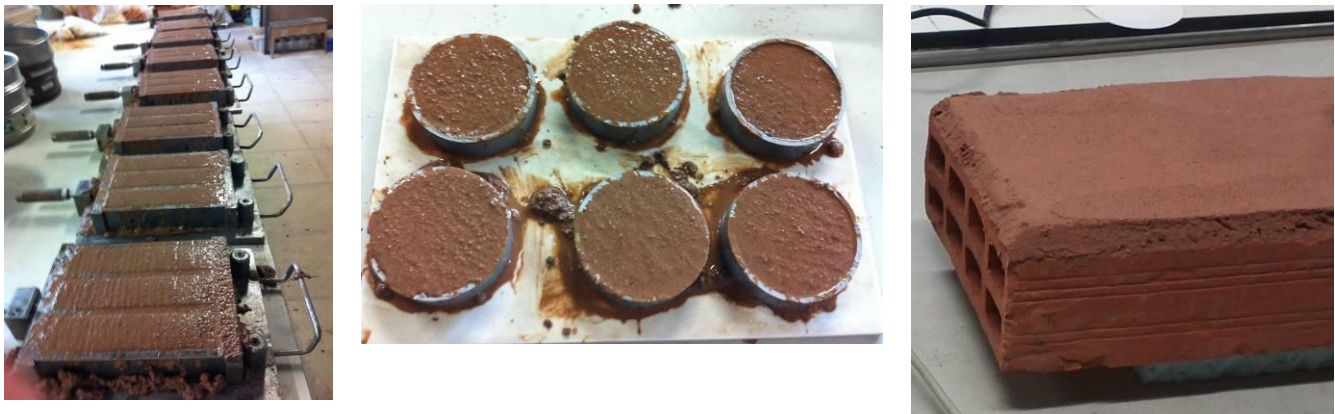
**Figure 5.** Prismatic (left), circular (middle) and on hollow brick mortar (right) samples

The prismatic and circular laboratory samples were let to dry for several weeks and then de-moulded. Together with the mortar samples on brick, they were placed in a laboratory with  $65\pm 5\%$  relative humidity (RH) and  $20\pm 3^\circ\text{C}$  temperature.

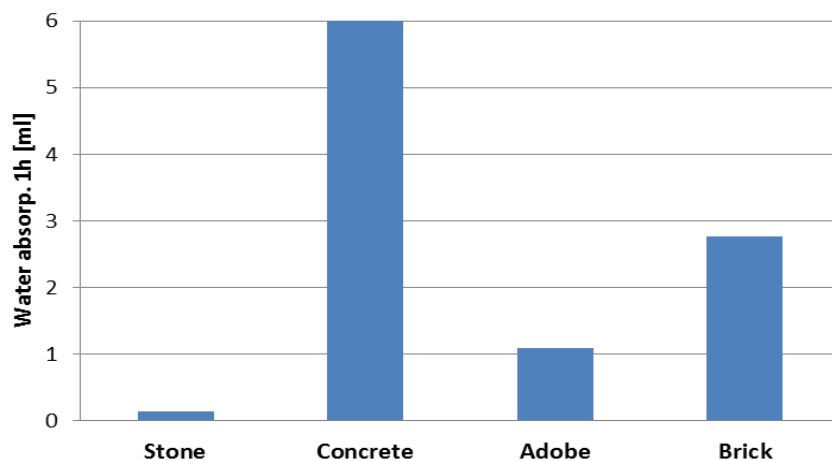
**Figure 6.** Water absorption under low pressure of the masonry materials

The water absorption under low pressure was determined by Karsten tubes for the four masonry units: the limestone of the rubble stone masonry, the concrete block, the adobe block and the hollow brick. Results of water absorption after 1 hour test are registered in Figure 6. The absorption of the concrete blocks was so high that turned difficult the measurement of the water intake. In fact the water of each karsten tube (4ml) was immediately absorbed by the concrete blocks and the maximum water absorption presented in Figure 6 is only indicative.

Particularly the total water absorption of the rubble stone masonry (with higher percentage of masonry mortar) but also of the other masonries will be affected by the water absorption of the correspondent masonry mortars. For that reason, the masonry units water absorption (Figure 6) is only indicative of the water absorption global behaviour of the masonries.

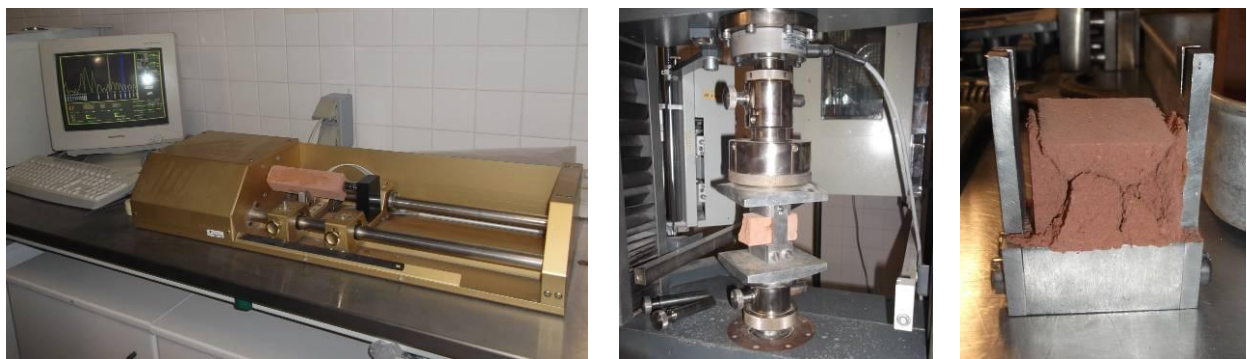
**Figure 7.** Sample being tested for dynamic modulus of elasticity (left) and for compressive test - being tested (middle) and conic fracture (right)

The dry bulk density  $D$  of the hardened mortar was determined based on DIN 18947 [4], by measuring and weighting of the prismatic samples, in equilibrium at 65% RH and  $20^\circ\text{C}$  temperature. The dynamic modulus of elasticity  $E_d$  was determined based on EN 14146 [10], using a Zeus Resonance Meter equipment (Figure 7 - left) and, according to DIN 18947 [4], the flexural and compressive strength,  $F_{Str}$  and  $C_{Str}$  (Figure 7 – middle and right), were determined based on EN 1015-11 [5]. Results, in terms of average and standard deviation, are presented on Table 5.

According to Table 1, the mortar is classified in dry bulk density class 1.8. In terms of strength class, the mortar cannot be classified, as the adherence test had not been performed. But flexural and compressive results indicate that the mortar may be classified as S I.

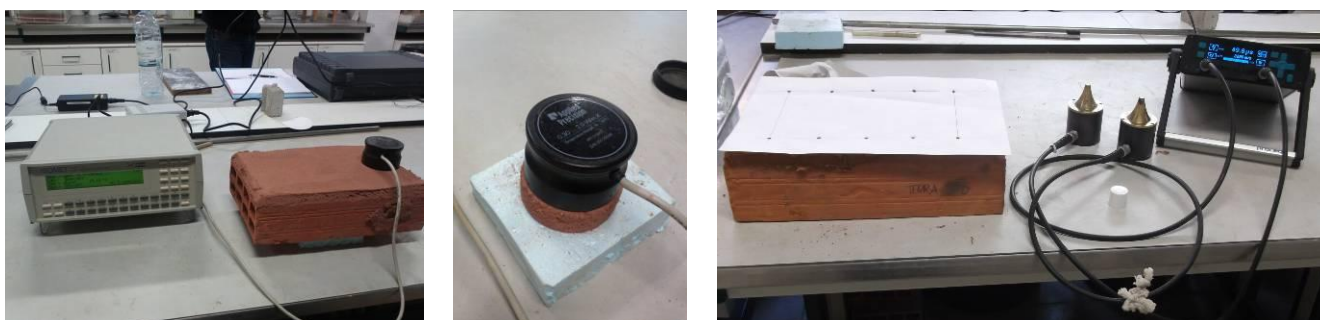
**Figure 8.** Mortar on brick (left) and circular samples (middle) being tested for thermal conductivity and equipment for ultra-sound determination (right)

The thermal conductivity of the earthen mortar on laboratory samples was determined at 65% RH and 20°C temperature by a Heat Transfer Analyser Isomet 2104 equipment, with a 60mm contact probe API 210412. The equipment test specification requires a minimal thickness of 1.5cm of the sample. The thermal conductivity  $\lambda$  was determined with the circular samples but also with the mortar samples on hollow brick (Figure 8 – left and middle). Results, in terms of average and standard deviation, are registered on Table 6.

The ultra-sound velocity on the samples of mortar applied on brick (Figure 8 – right) and on plaster panels on the experimental wall (Figure 9 - left) was determined with a Proceq Pundit Lab equipment, conic transducers and a frequency of 54 Hz, based on LNEC test specification Fe Pa 43 [14]. Through this test the compactness and the presence of eventual defects (like cracks or detachments) can be detected. The thickness (from the surface) of material that is analyzed depends on the

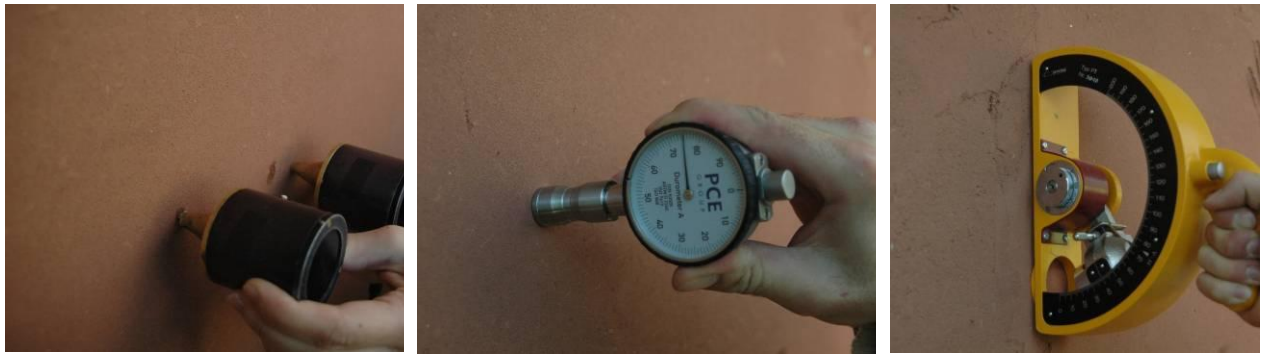
**Figure 9.** Ultra-sound (left), durometer (middle) and sclerometer (right) tests on plasters on the masonry test walls

The surface hardness was determined with a PCE durometer Shore A (Figure 9 - middle), based on ASTM D2240 [15], and with a pendular sclerometer Schmidt PT (Figure 9 - right), based on ASTM C805 [16]. The sclerometer was only applied on the plaster panels and not on the brick mortar samples because the impact of the test could damage these last samples.

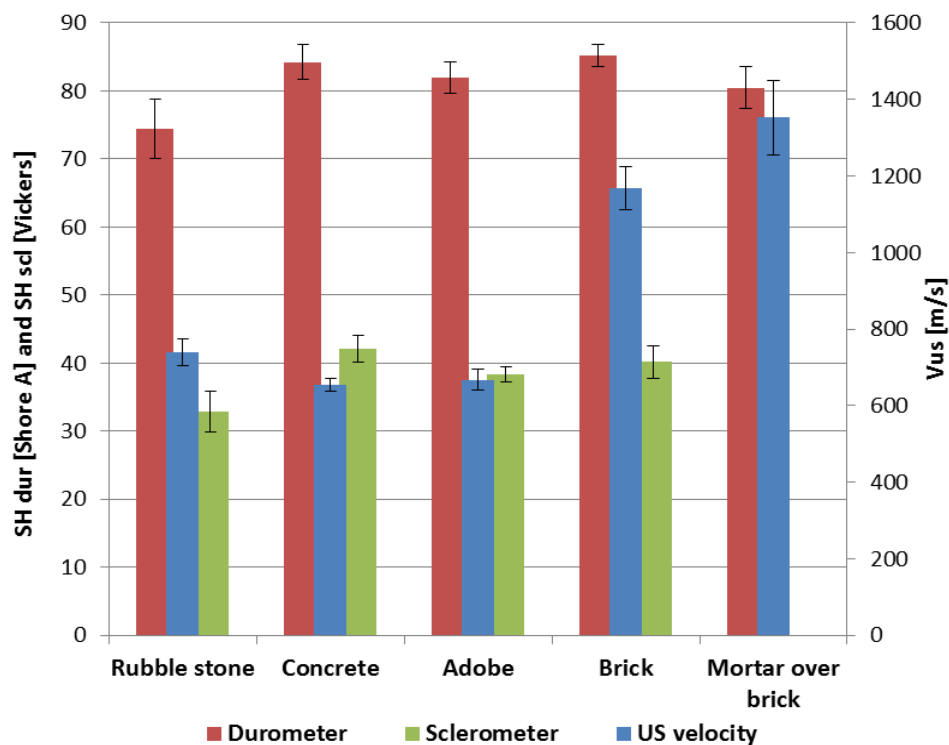
**Figure 10.** Ultra-sound velocity ( $V_{us}$ ) and surface hardness by durometer ( $SH_{dur}$ ) and by sclerometer ( $SH_{sc}$ ) of the plasters on the masonry test walls and on samples of mortar on brick

The average and the standard deviation results of ultra-sound velocity, surface hardness by durometer and sclerometer are presented in Figure 10.

It can be noticed that the ultra-sound velocity is much higher when the mortar is applied on brick masonry (and on brick samples), compared to the other types of masonry. This may be due to the fact that rubble stone and adobe masonries are compact walls. The concrete blocks also present a much higher thickness of the superficial face, compared to hollow brick, which ceramic shell does not even achieve 1 cm thickness. Comparing the brick masonry with the concrete block masonry it can also be due to the fact that the water absorption under low pressure of the concrete blocks is much higher than the one of the bricks (Figure 6). For that reason, the mortars' microstructure may be differently affected by the type of masonry. This aspect will have to be further studied, namely by porosimetric tests, in the continuity of the present study. It can also be mentioned that the standard deviation is higher for brick samples. That can be due to the fact that, when the transducers are more distant from each other, it is more probable that the ultra-sound can reach the shells of the individual bricks in the samples. This is due to the fact that the mortar layer is a little less thick compared to the plasters on the brick masonry wall.

Concerning the superficial hardness, both by durometer and pendular sclerometer, it can be noticed that results, although in different scales, indicate the same tendency: the surface hardness seems to be lower for the plaster applied on the rubble stone masonry, while it is similar for the plasters applied on concrete, adobe and brick masonries.

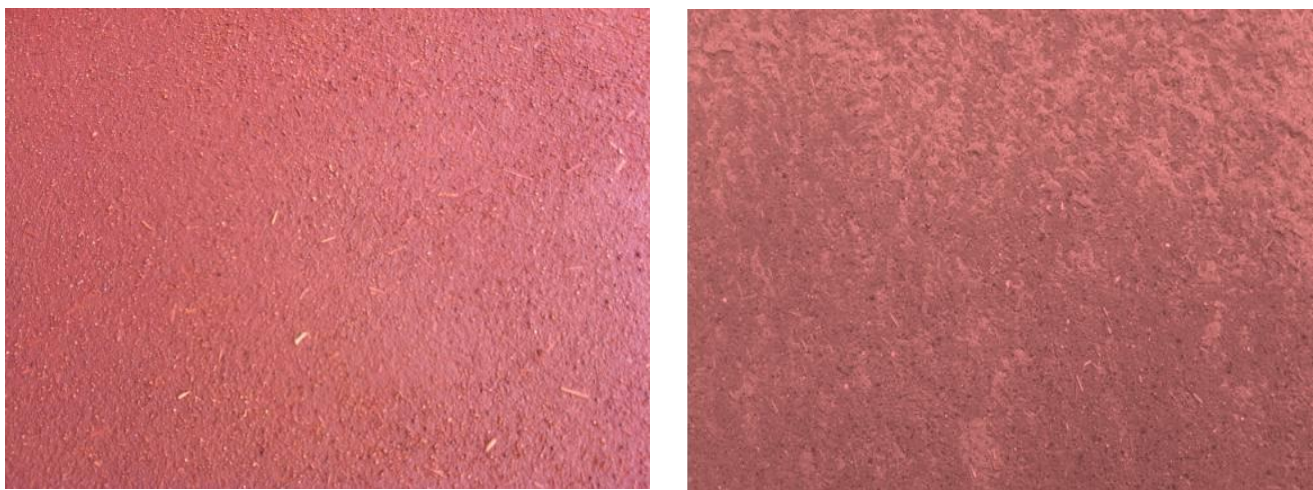
**Figure 11.** Visual observation of the plaster applied on one of the experimental masonry walls: protected area (left) and unprotected area (right)

The plasters applied on the test walls were visually observed throughout six months and the following points should be mentioned. As said before, degradation occurred on the underside of the plasters facing south, due to rainfall projected by wind before the protective net was applied. A reduction of clayish particles could be observed, being the particles of sand more visible (Figure 11 – right) in comparison with the same plaster but in protected area (Figure 11 – left). As expected and defined by the producer, this mortar can be applied as plaster but not currently as render. As render it can only be applied when completely protected from rainfall. In all the surfaces, in exterior environment but water protected, no degradation was noticed.

Finally, the natural pigmentation of the plaster and its texture, with the effect of the vegetal fibres, must be mentioned (Figure 11- left). The fact that it does not need to be coated by a paint system for aesthetic reasons may eliminate the consumption of resources. At the same time the uncoated surfaces of the plasters will be able to contribute for the regulation of the relative humidity of the interior environment [17].
